# INVESTOR PROSPECTUS WHEELING WV

*The Blue Church*  
*1206 Byron Street*

## **Building Condition Report**

**October 31, 2013**

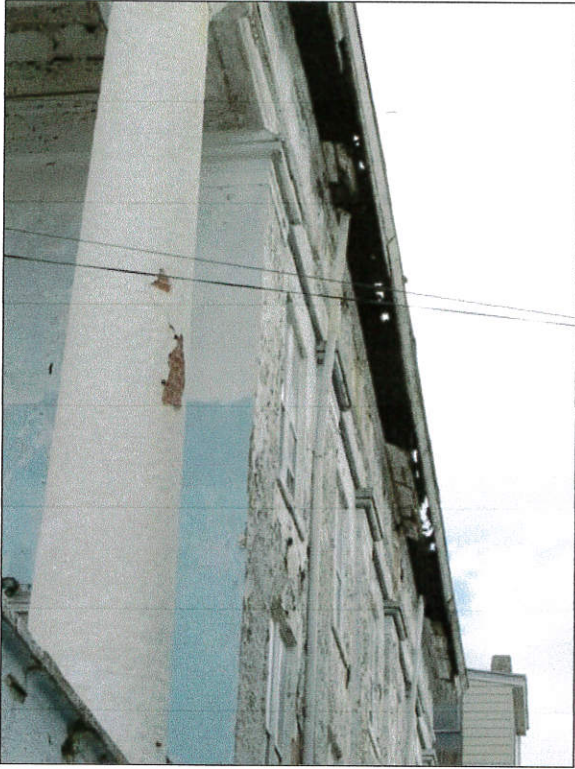
South Side Eave/Missing Column Flutes

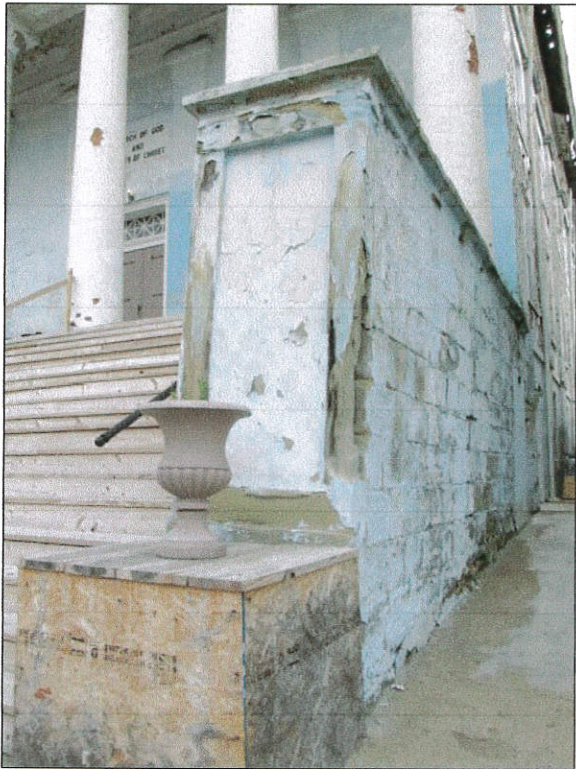
Flanking the front stairs are two “wing” walls that contain the original stairs. The southerly wall is listing and needs stabilized. Both the north and south walls have eroded stone components that need stabilized and/or replaced.

Stair Wing Wall

- Repair opening mortar joints and cracked masonry at the cheek walls at the main entrance stairs. Additional investigation of the south-west cheek wall and foundation is appropriate due to the rotation of this element.

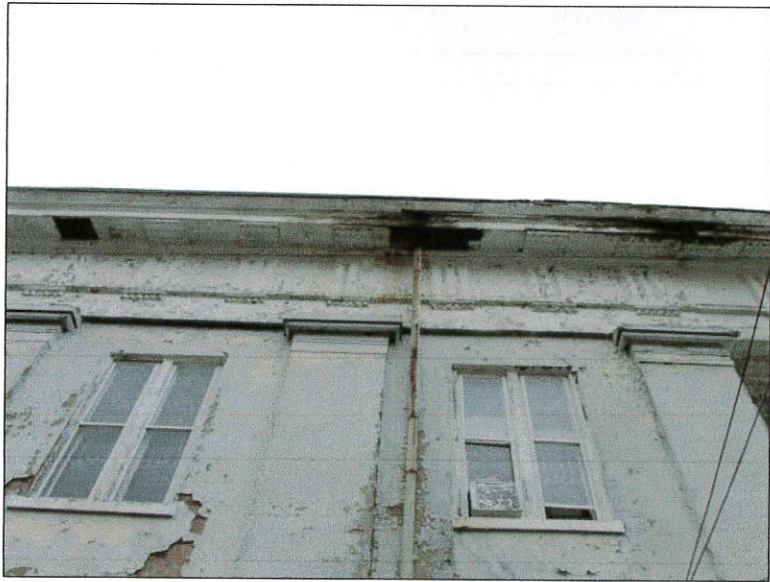
Missing Stucco, Downspout and Peeling Paint

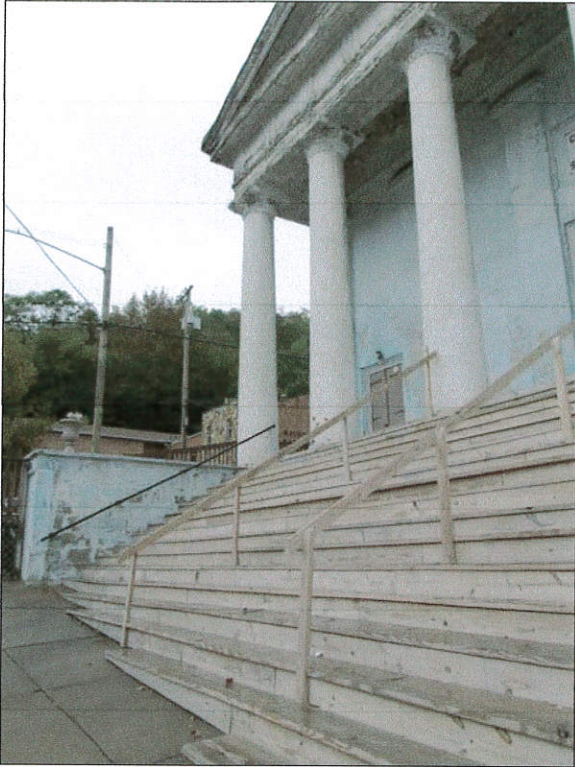
The front portico and steps should be considered in this priority. It is difficult to determine the condition of the stone under the pressure treated wood stair cover but it is assumed that the stone is in bad condition. The wood stairs (press. trtd. 2x12s with a 2x filler) are “cupping” (due to lack of “kerfing”) and the handrails are non-code compliant. In this priority repairs to the wood stair and added rails could be a short term solution to improve the stairs. The concrete slab at the top of the stairs is worn and there is evidence of repairs that were made. The concrete is cracking and the concrete at the door thresholds is crumbling. The proper repairs to this slab is included in this priority to prevent further damage and to protect the basement area under the portico that hold existing toilet rooms.

Wood Clad Stone Front Stairs

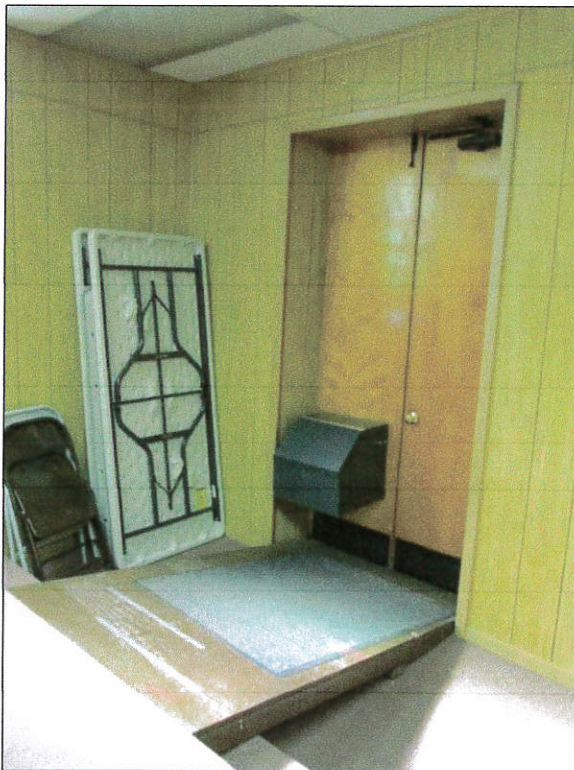
There exists a wood HC ramp that allows access to the portico. Once on the portico there are steps to the two remaining entry doors. There needs to be improvements to create an accessible route as this current path is ADA deficient.

Ramp at Southerly Entry

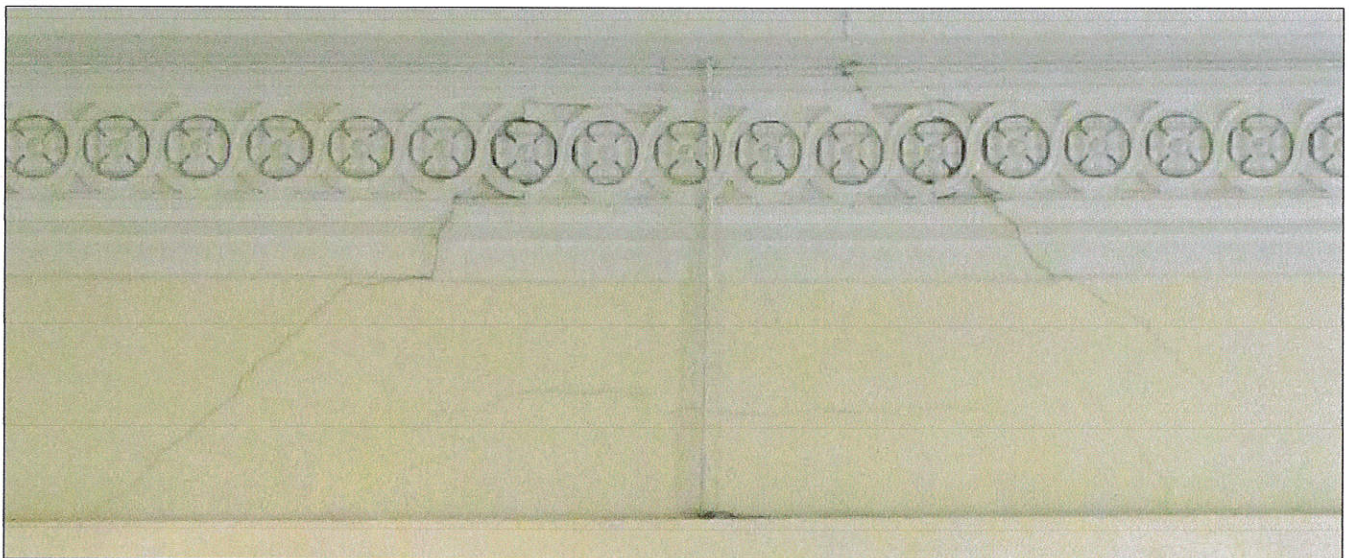
Nave/Balcony Deteriorated Entablature

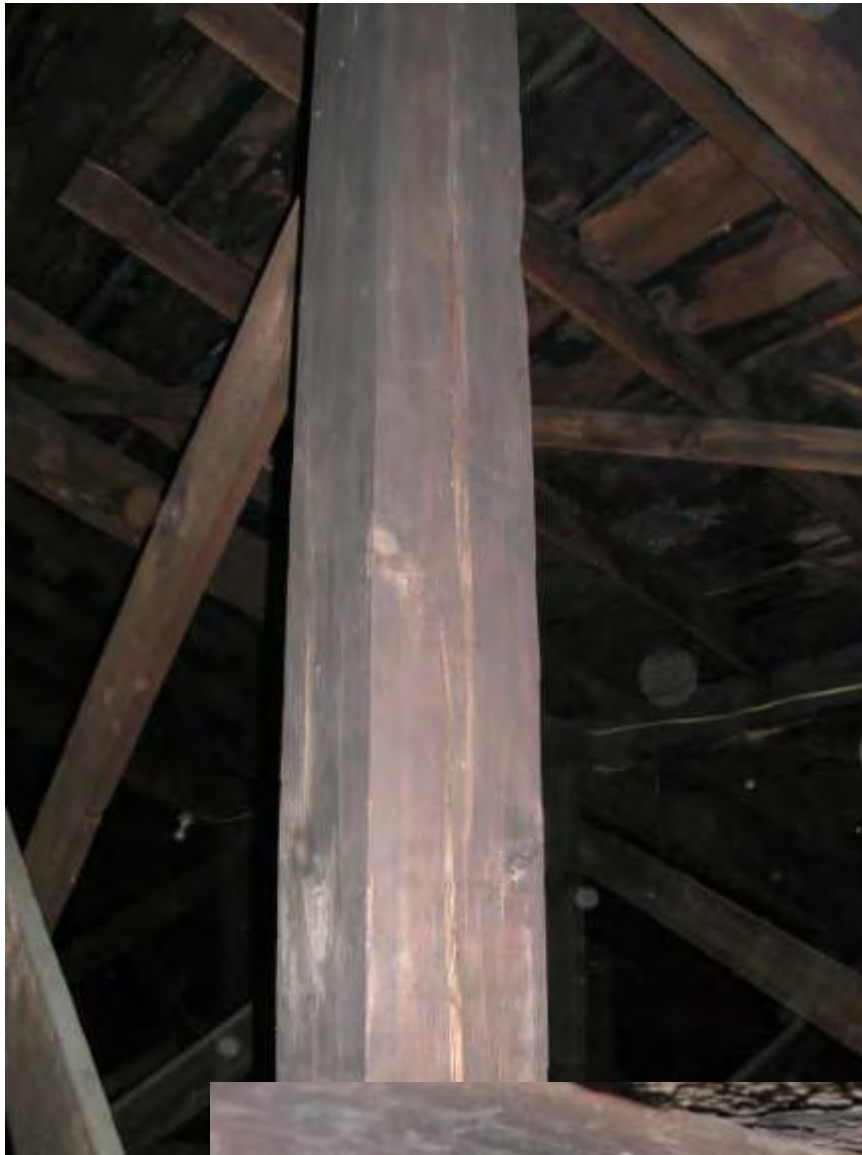
The roof trusses are spaced at approximately 9'-4" on center and consist of heavy timber framing members. As noted previously, a sketch of the basic truss profile is located at the end of this letter report. The profile shows the general configuration of the truss and the approximate location of the suspension rods for the balcony support. The framing and trusses are shown in Photos 10 through 20. The roof rafters are spaced at 24-inches on center and are supported by heavy timber purlins that span between the trusses (Photo 10). There are some diagonal braces between the trusses for lateral support of the trusses (Photo 11). In a few locations, there is evidence of some minimal movement of members. This is seen in Photo 13 where the diagonal member appears to have shifted where it is in contact with the top of the truss or top chord. There are also heavy timber members that are basically laying on the bottom chord that support the suspended rods for the balcony. These can be seen in Photos 13 through 15 and the suspension rod anchorage is seen in Photo 16. There does not appear to be any mechanical connection between the members supporting the suspension rods and the timber trusses. Photo 17 shows a cracked

Photo 17. Cracking/Checking in Vertical Timber Post

- Mechanically attach web members to chord members where they have shifted.
- Splice truss members where cracked or checked.
- Attach rafters to purlins/beams where they are lifted or separated.

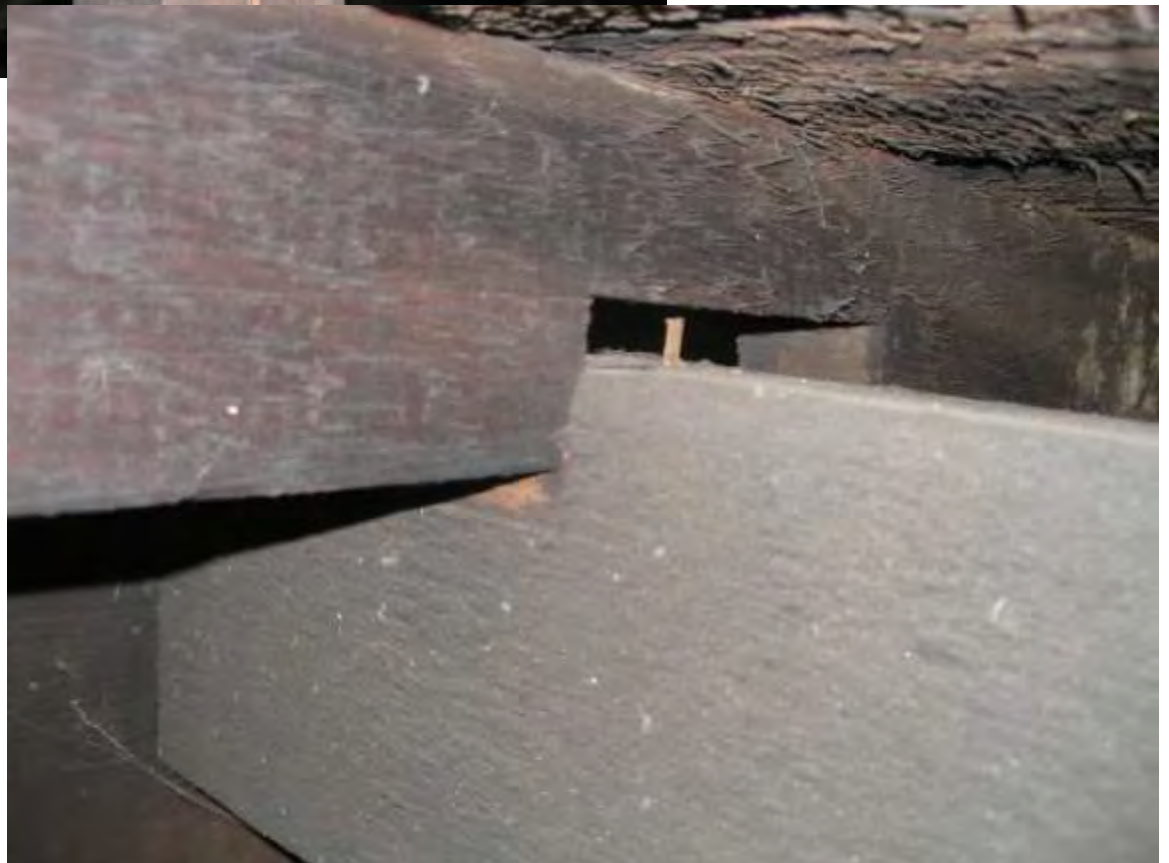
or checked vertical timber post and Photo 18 shows a roof rafter that has lifted up from the support beam or purlin. A crack in the top chord at a support notch is shown in Photo 19. The deterioration of the framing at the north eave is shown in Photo 20.

Photo 18. Roof Rafter Lifted Up From Support Beam

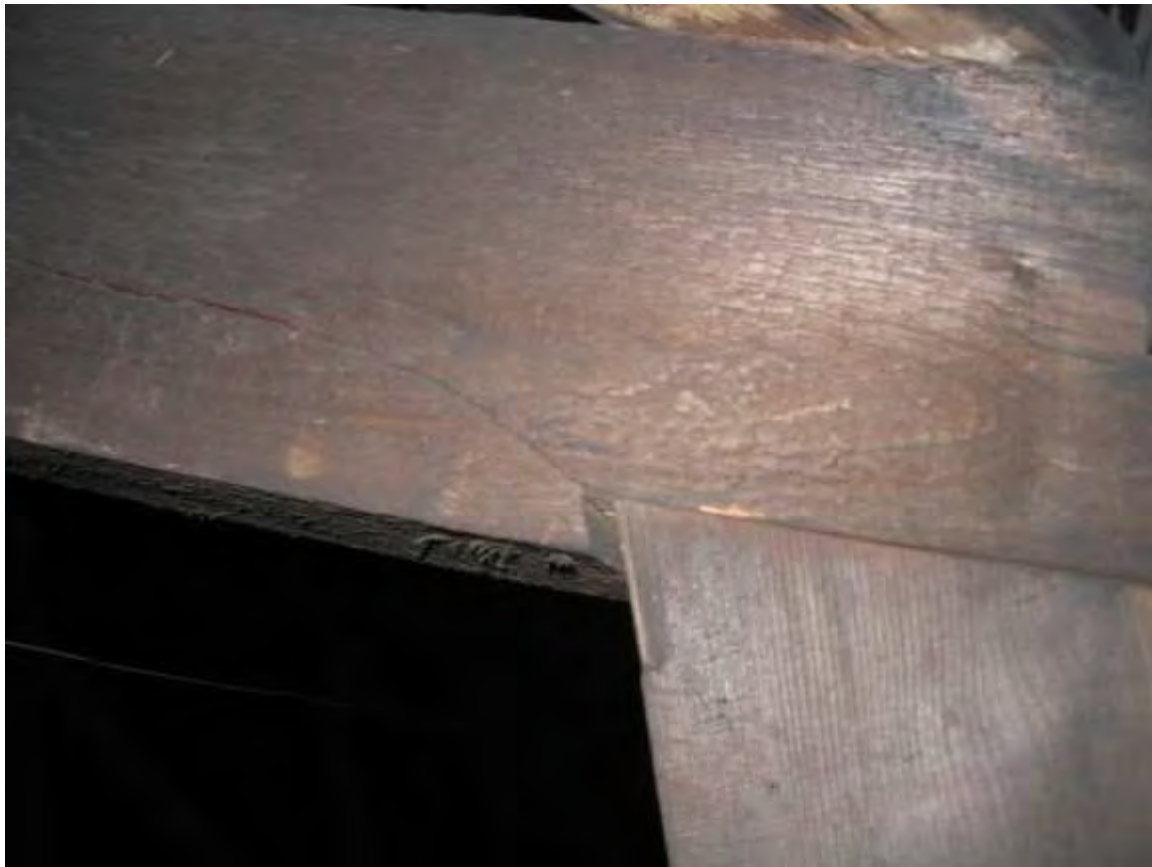
Photo 19. Cracking at Support Notch at Top Chord of Roof Truss

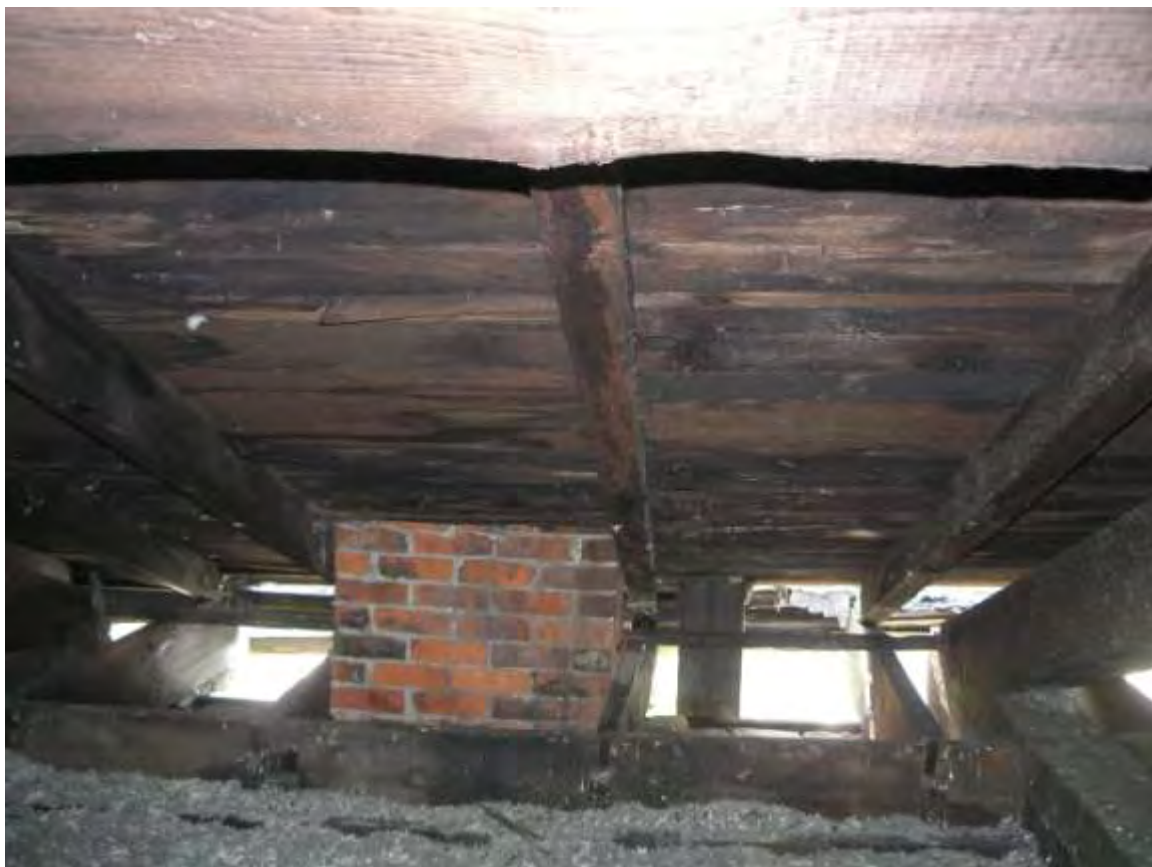
to determine if the top chord overstress is actually a concern. The truss that supports the back of the balcony with the four (4) suspension rods was not analyzed at this time. Only typical truss loading cases were analyzed. **There is serious deterioration at the ends of the trusses at the eaves that will require repairs.**

Photo 20. Deterioration of Framing at North Eave

- Repair the ends of the trusses at the eaves where the members are deteriorated. Depending on the level of deterioration, repairs can consist of epoxy wood repair materials, sistering with additional wood framing or replacement of the member.

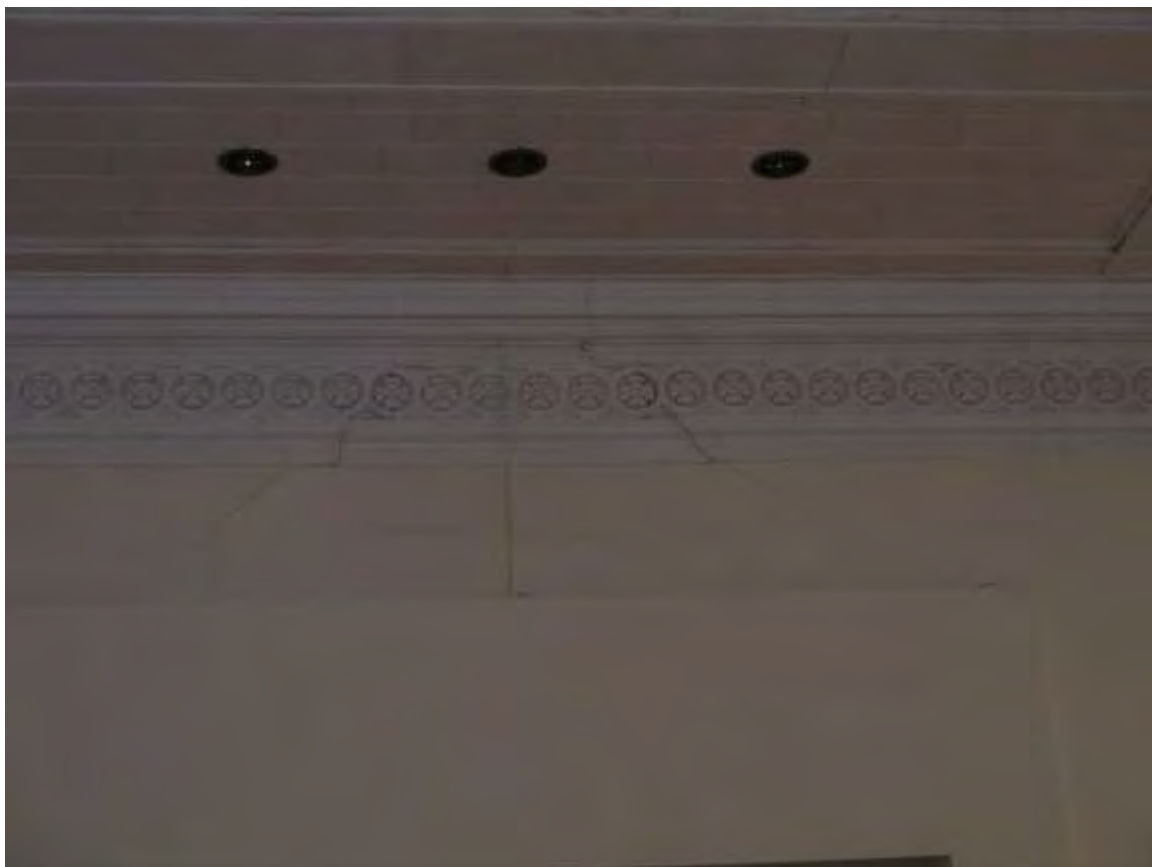
There is a wide opening at the front of the church at the ambo, seen in Photo 25. The plaster above the opening is cracked in an inverted "V", as seen in Photo 26. The support for the brick masonry above this opening is not known and appears that it may not be adequate as this cracking is in line with typical arching action of brick, where the masonry below the inverted "V" is subject to becoming dislodged without proper support.

**As noted in the Existing Conditions section of this letter report, the support of the brick masonry over the opening at the front of the church is not known. The cracking that is apparent is a structural concern and additional investigation is warranted to be able to complete the analysis and develop a repair solution.**

Photo 26. Cracks Above Opening at Front of Church

- Investigate the structural support for the brick masonry at the opening at the front of the church.
- Reinforce notches of any balcony floor joists that are cracked.

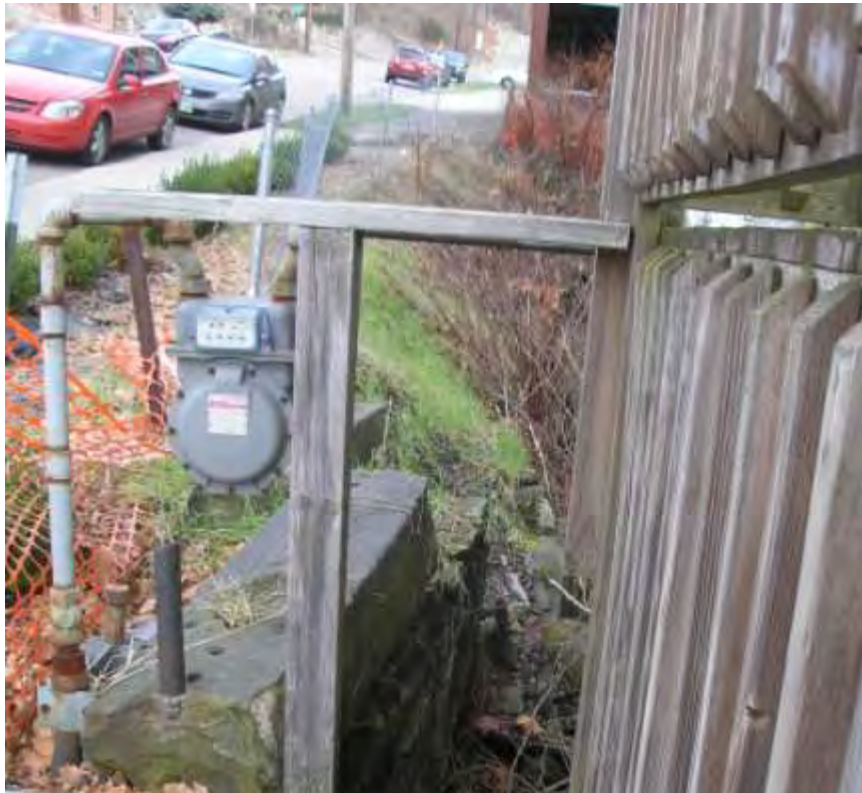
Exterior conditions can be seen in Photos 27 through 36 and are related to the conditions of the existing stone retaining wall along the north elevation and the cheek walls on both sides of the main entrance stairs. As can be seen in the photos, there appear to be structural issues related to the stone retaining wall. It is our understanding that there were some water problems which led to the reconstruction of the sidewalk along the north side of the building. The retaining wall appears to be leaning toward the building and the structural adequacy of the wall and foundation is not known at this time. The cheek walls at both the north-west and south-west corners of the main entrance stairs show evidence of deterioration with open mortar joints, cracking and rotation of the south cheek wall.

Photo 27. View of Retaining Wall along North Elevation of Building

- Repair or reconstruct the stone retaining wall along the north elevation of the building adjacent to the sidewalk.

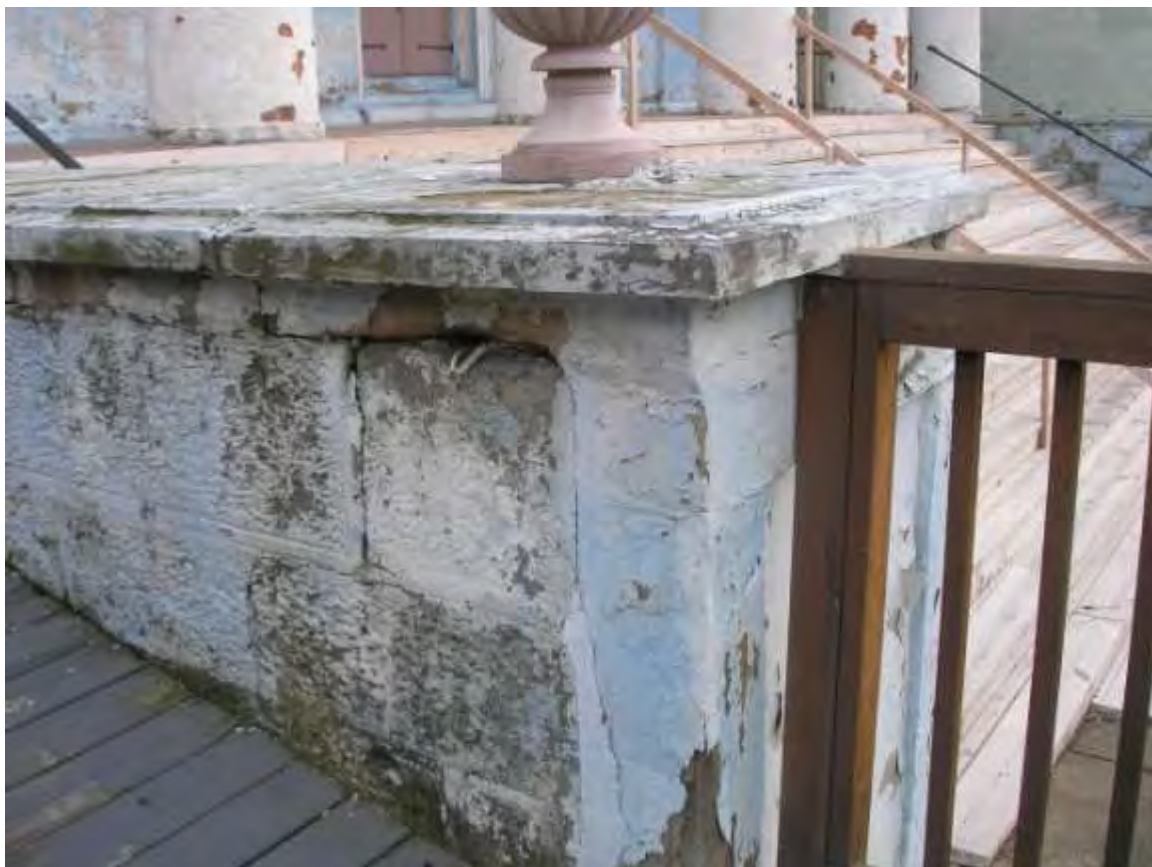
Photo 30. Cheek Wall at North-West Corner of Steps Showing Open Joints

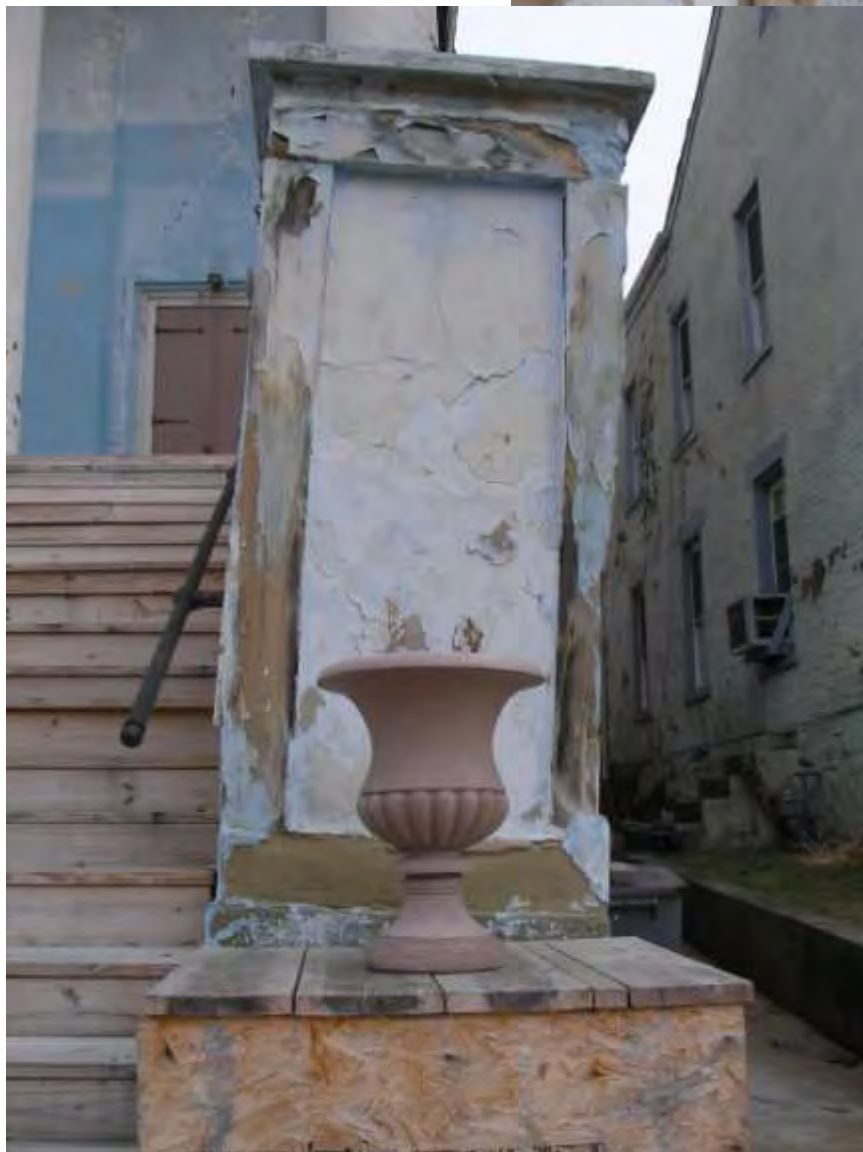
Photo 36. End View of Cheek Wall at South-West Corner of Steps Showing Wall Movement to the Outside
