722-724 Main: Update #4, May 2022

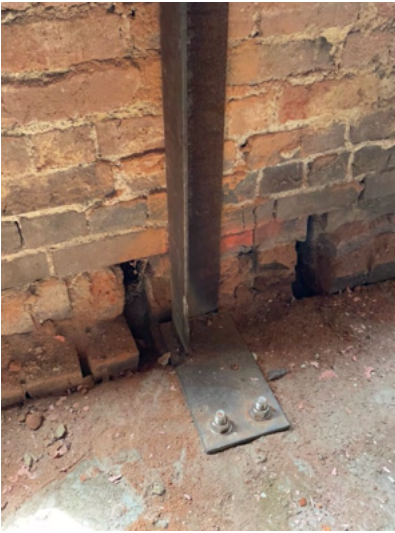
Steel beams have now been installed along the interior walls on the front and alley sides of the duplex – one beam on the front of each of 722 and 724 Main and five beams along the alley side. The first floor flooring was first removed to allow for new concrete footers. Then the beams were attached to the footers (shown on the left).

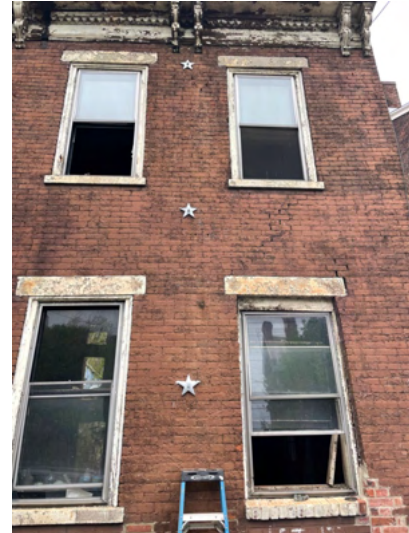
Bolts through the brick walls anchor the walls to the steel beams with star-shaped plates on the front and diamond-shaped plates

on the side. (Stars on the front of 724 Main are pictured.)
