# INVESTOR PROSPECTUS WHEELING WV

*The Blue Church*  
*1206 Byron Street*

## **Building Condition Report**

**October 31, 2013**

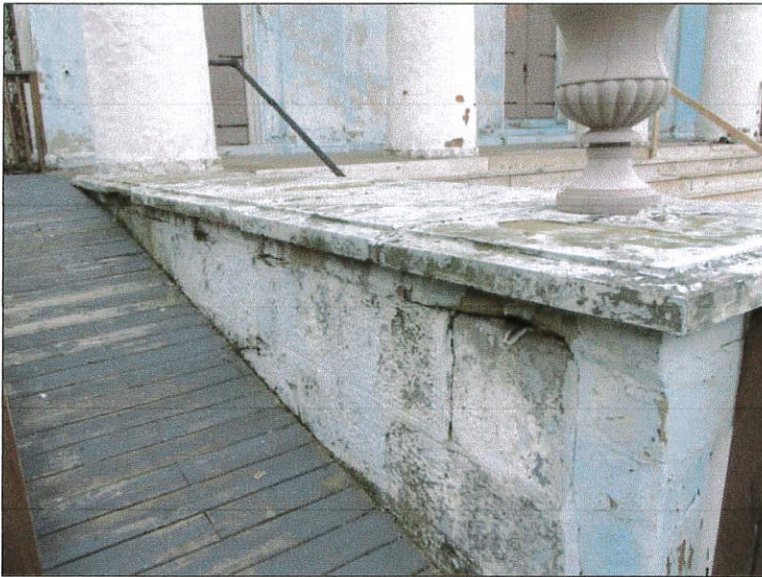
HC Ramp

There exists a wood HC ramp that allows access to the portico. Once on the portico there are steps to the two remaining entry doors. There needs to be improvements to create an accessible route as this current path is ADA deficient.

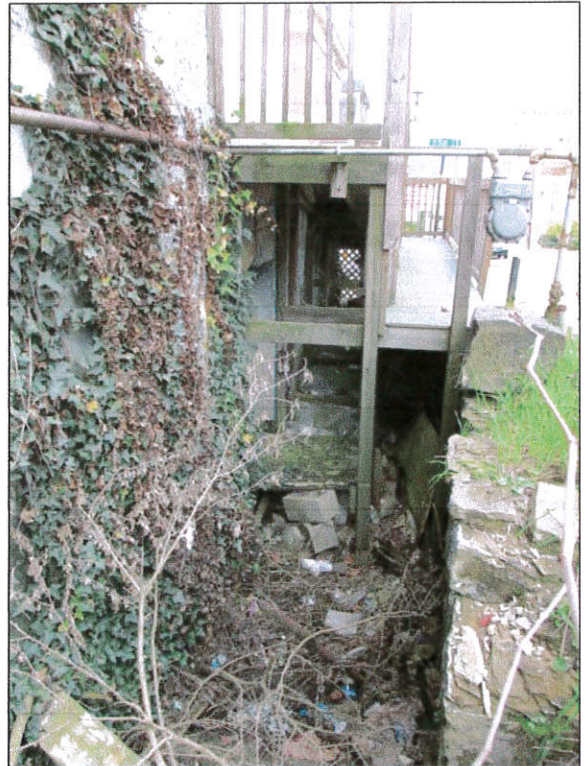
Failed Retaining Wall

Along the north side of the Church there is a stone wall that retains the adjacent sloping lawn, sidewalk, and street. The wall is set back approx. 5 ft. from the north façade thus creating a light well for the fellowship hall windows. The wall's stones have failed and the light well is filled with debris and overgrowth of plants and weeds. This presents an unsafe pedestrian condition and a collecting point for precipitation.

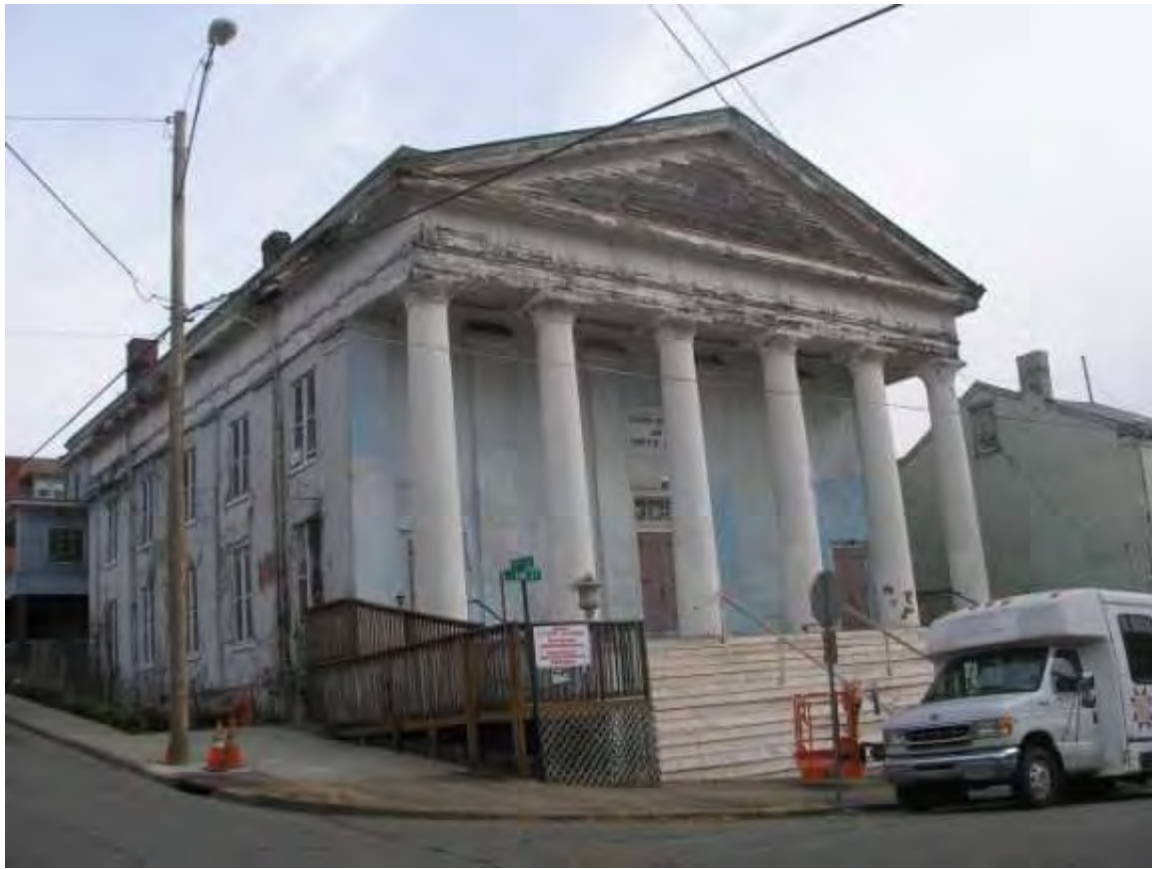
The exterior of the building is shown in Photo 1 and appears to consist of painted stucco over exterior brick masonry. The condition of the exterior is such that a number of repairs are needed and are addressed in a separate report prepared by SMG Architects, dated October 31, 2013. Existing conditions of the interior of the main floor and balcony are shown in Photos 2 through 5. As seen in Photos 6 and 7, the balcony is supported from the roof structure by iron suspension rods at several locations. Additionally, the balcony is sloped or raked, with built-in fixed risers (see Photos 8 and 9).

Photo 1. View of Front Entrance of Church

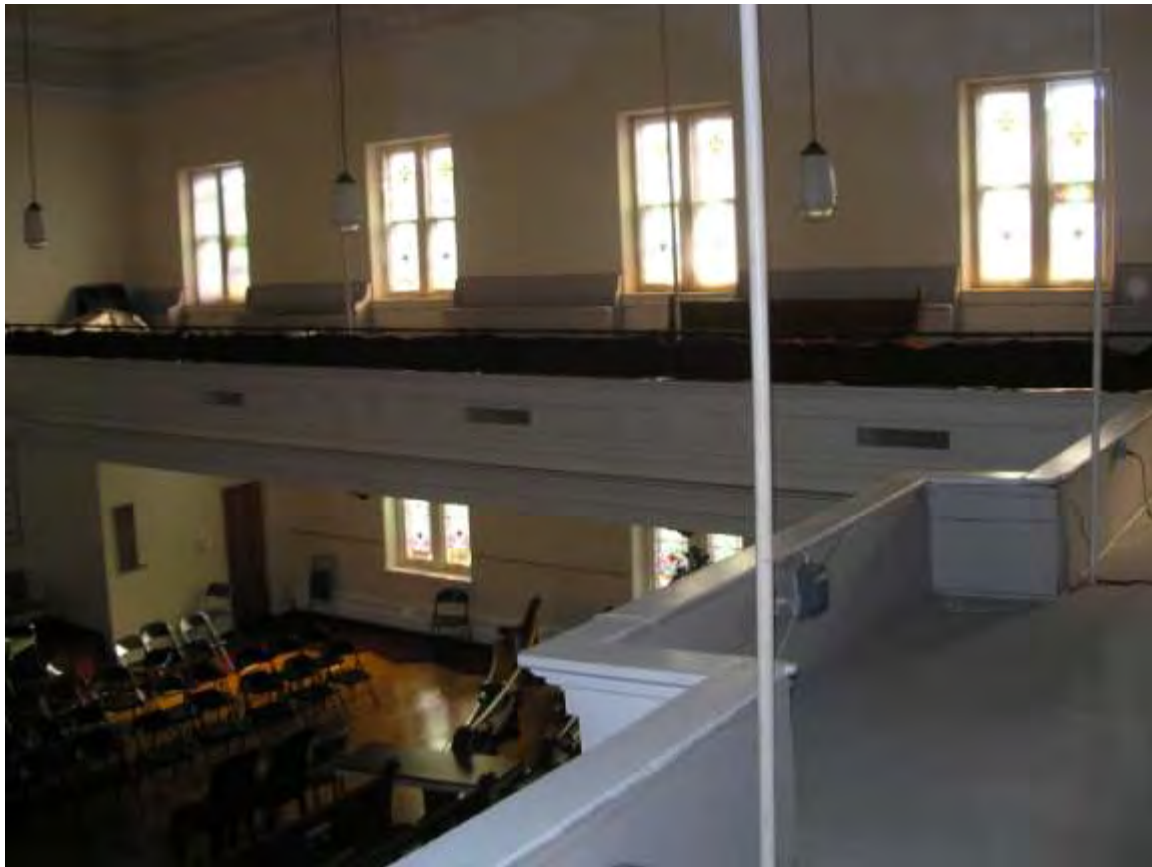
Photo 3. View from the Balcony showing Suspension Rods

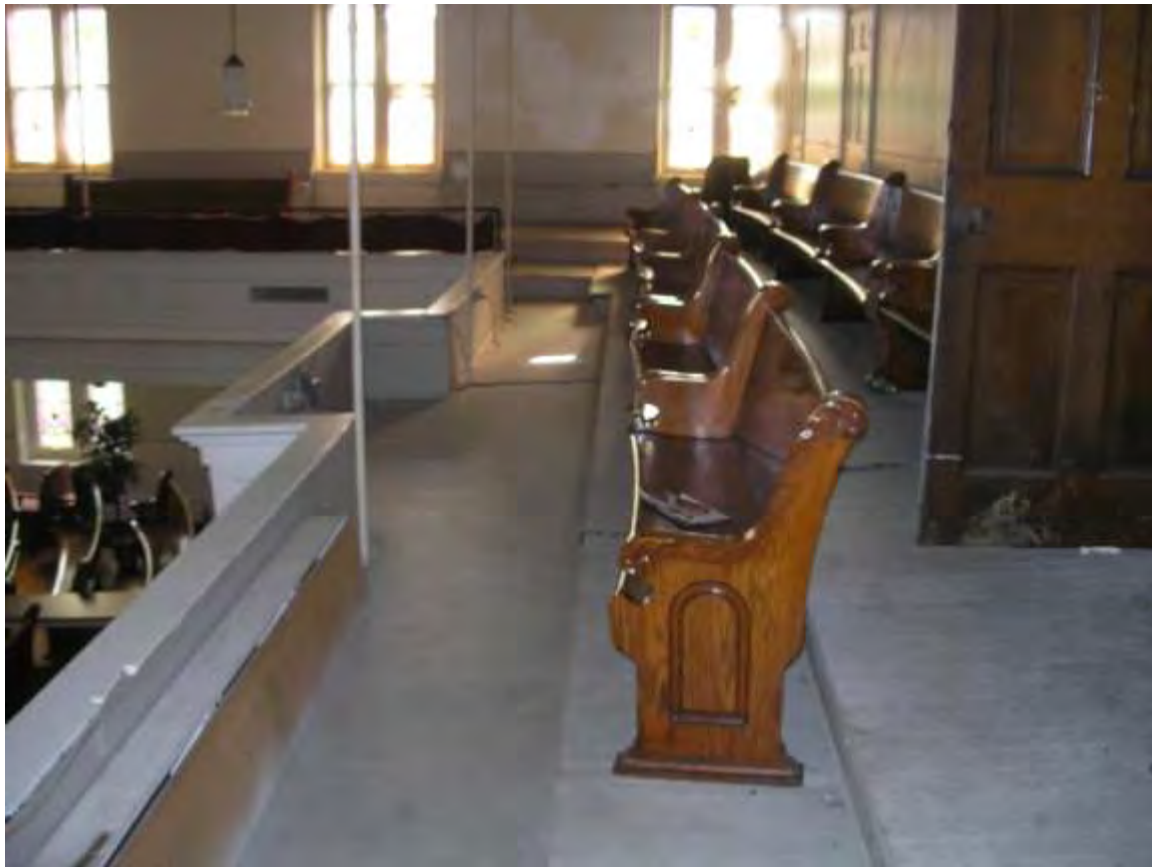
Photo 9. View of Balcony along Rear of Church

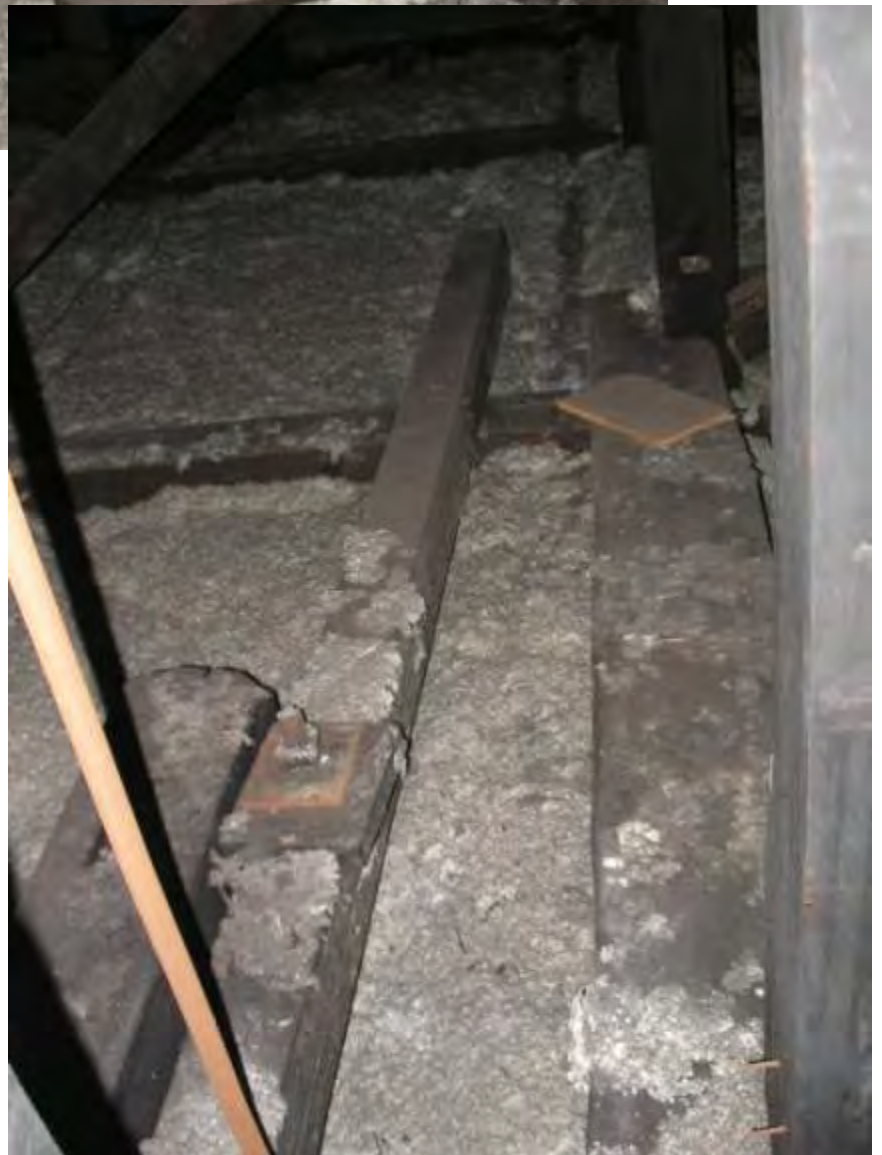
Photo 14. Heavy Timbers at Bottom of  
Roof Truss Support Suspended Balcony  
Below

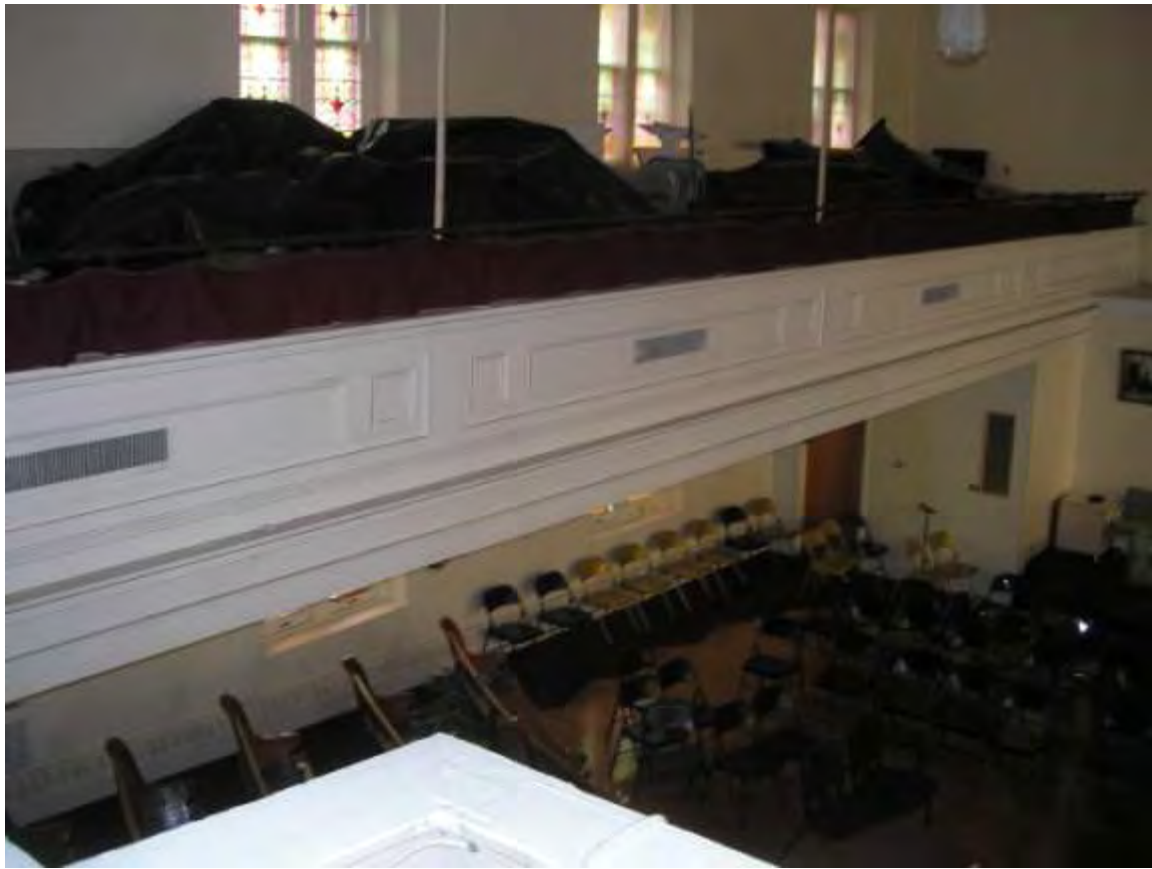
The side face of the balcony again showing the suspension rods is shown in Photo 21 and the bottom sloped ceiling of the balcony can be seen in Photo 22. The 1-1/2 inch diameter suspension rod at the location where it goes through the balcony framing is seen in Photo 23 and a portion of the sloped balcony framing is shown in Photo 24. The back of the balcony has four (4) suspension rods. Two of these appear to continue up to the top chord of the truss.

Photo 21. Suspension Rods Supporting Balcony

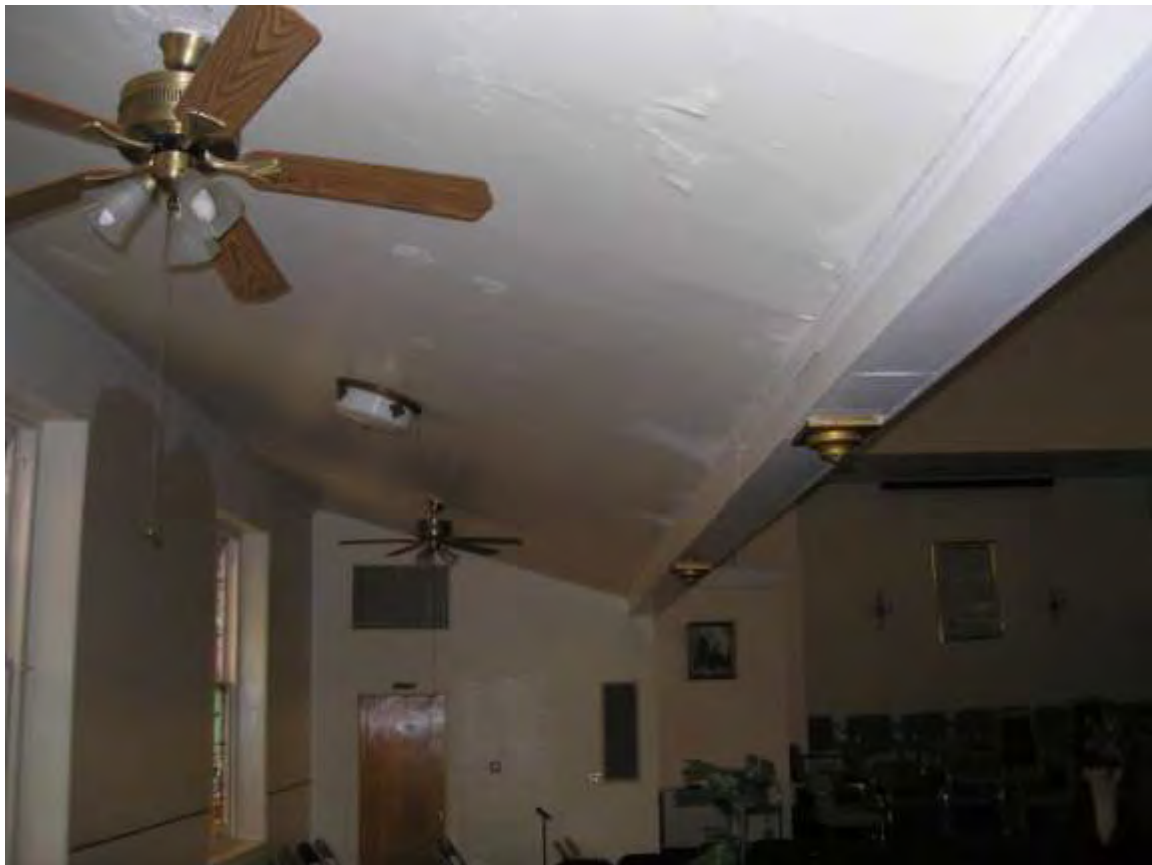
Photo 22. Sloped Ceiling below Balcony Showing Suspension Rod Support Locations

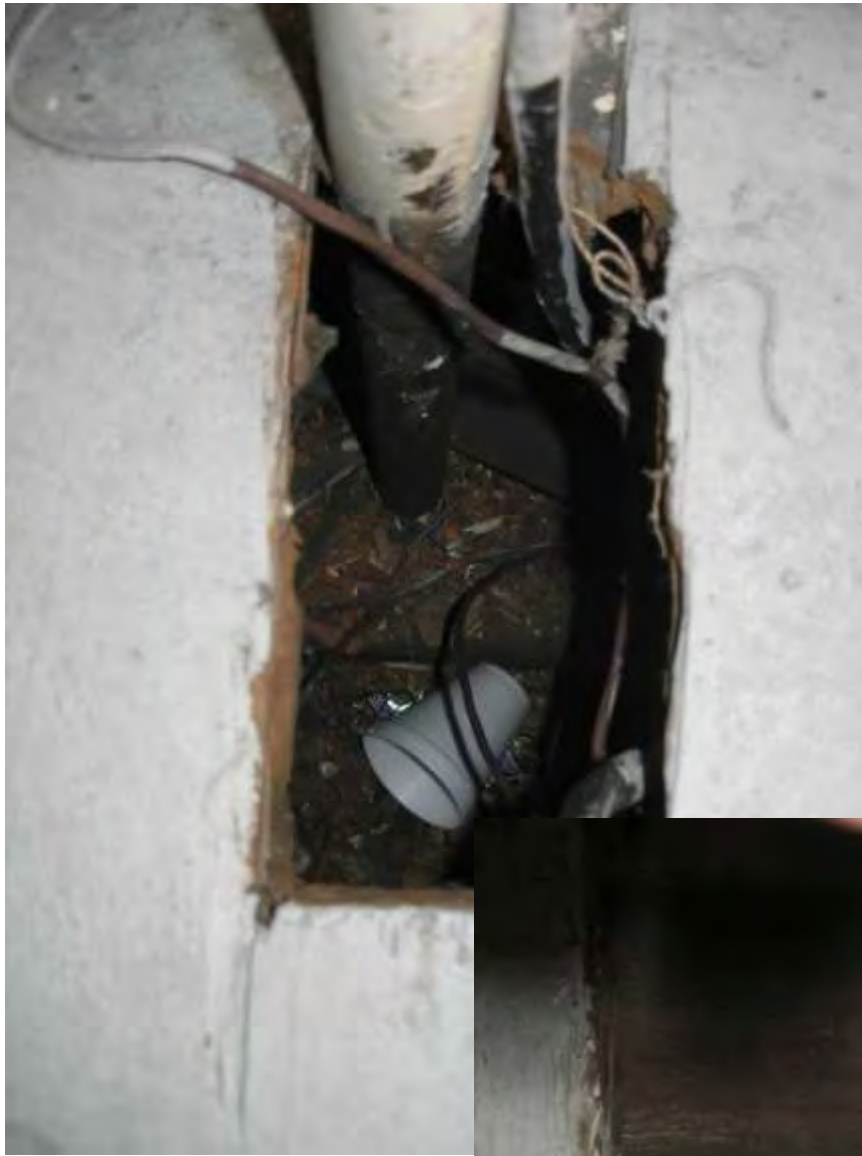
Photo 23. Suspension Rod through  
Balcony Framing

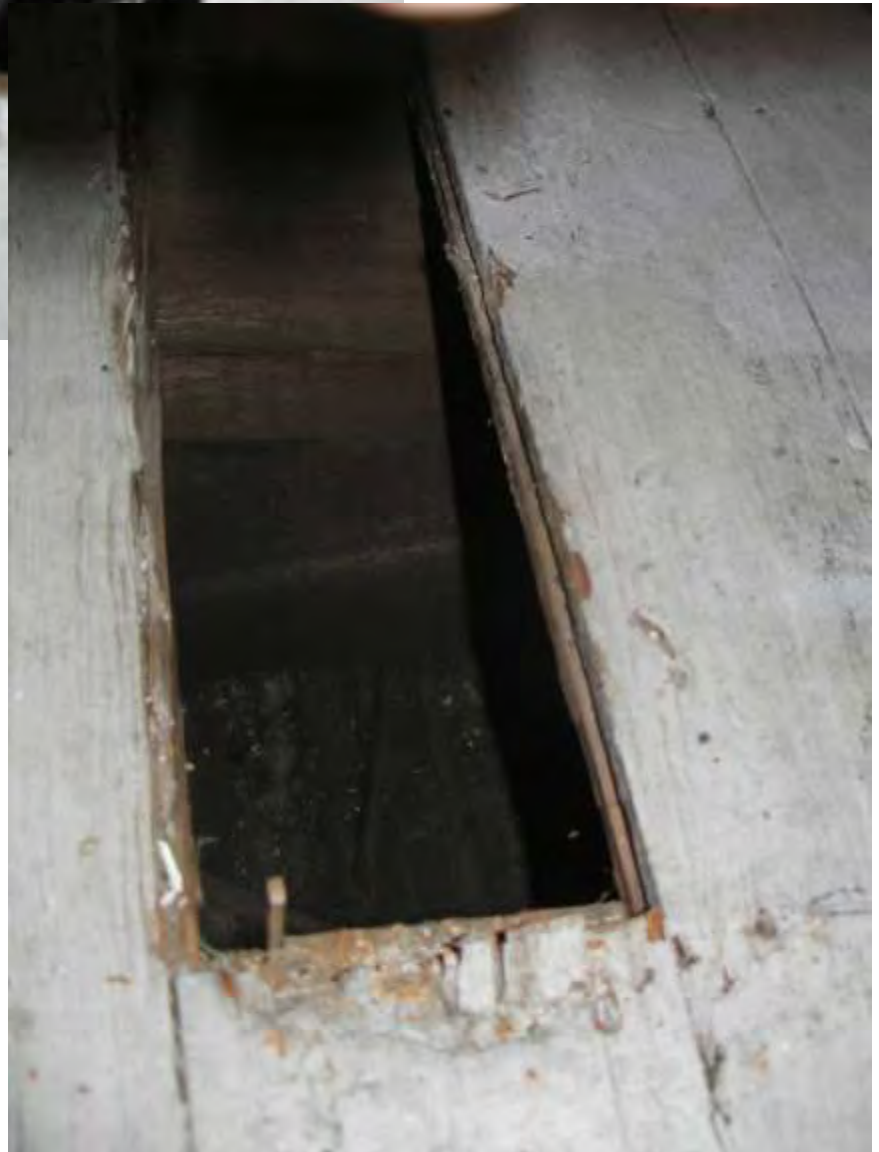
The balcony framing consists of 2x10 joists spaced at 16-inch centers. The joists are sloped with tapered portions of 2x's sitting on top to create the fixed riser configuration seen in the photos. Some of the joists are deeply notched at the bearing end where they are pocketed into the exterior brick wall. While the notches exceed current code allowable depths, the shear and bending capacity of the members appears to be adequate for the anticipated loads. If cracks are observed at the notches they should be reinforced. The size and configuration of the outermost structural beam member that is supported by the suspension rods could not be determined without removing finish materials. Therefore, the adequacy of that element could not be analyzed.

Photo 24. Flooring and Framing at  
Balcony

- Investigate the structural support for the brick masonry at the opening at the front of the church.
- Reinforce notches of any balcony floor joists that are cracked.

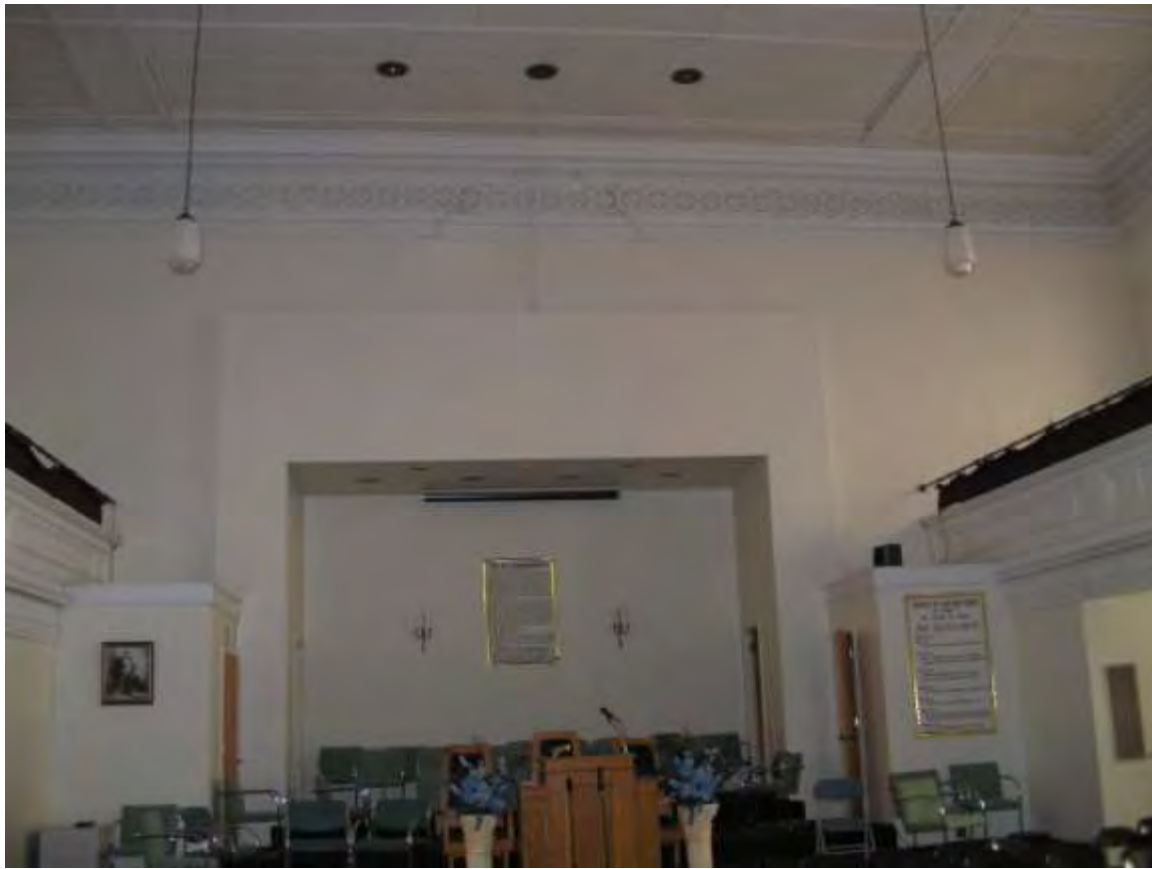
There is a wide opening at the front of the church at the ambo, seen in Photo 25. The plaster above the opening is cracked in an inverted "V", as seen in Photo 26. The support for the brick masonry above this opening is not known and appears that it may not be adequate as this cracking is in line with typical arching action of brick, where the masonry below the inverted "V" is subject to becoming dislodged without proper support.

**As noted in the Existing Conditions section of this letter report, the support of the brick masonry over the opening at the front of the church is not known. The cracking that is apparent is a structural concern and additional investigation is warranted to be able to complete the analysis and develop a repair solution.**

Photo 25. View of Altar/Ambo Area at Front of Church

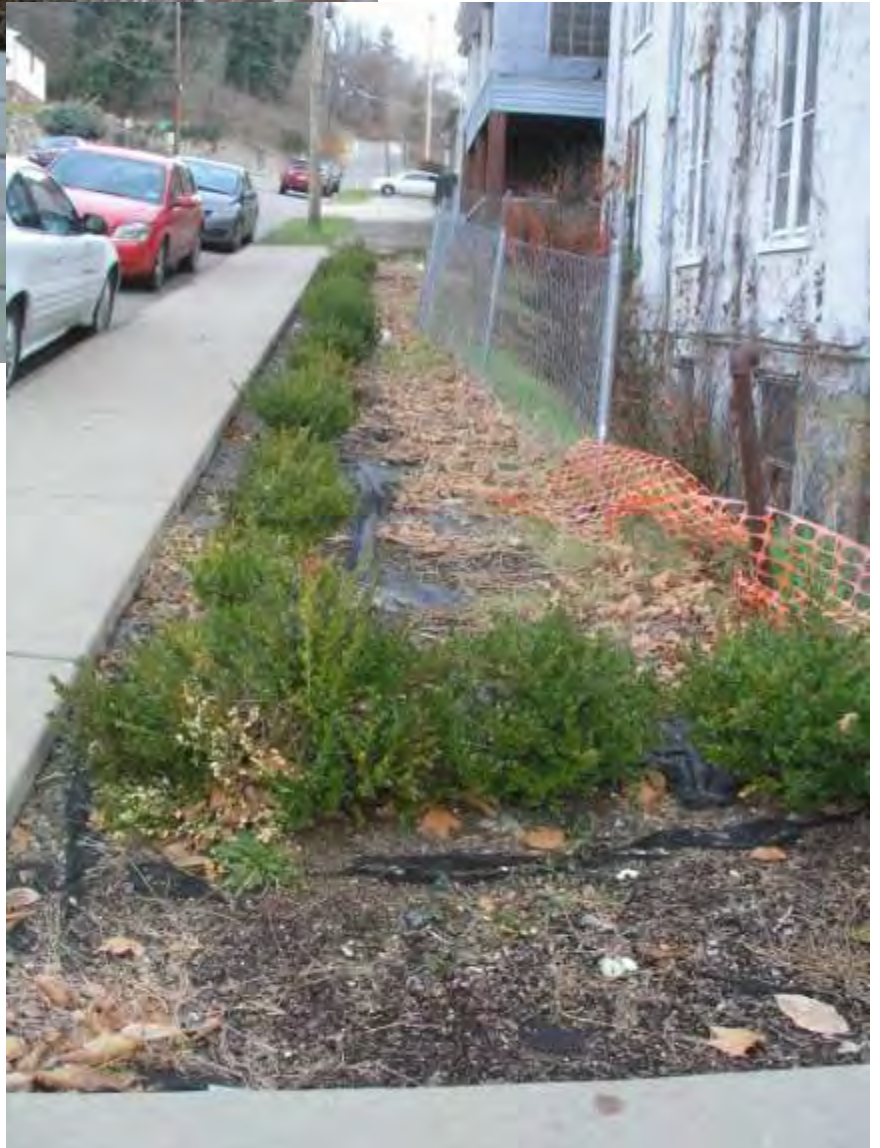
Exterior conditions can be seen in Photos 27 through 36 and are related to the conditions of the existing stone retaining wall along the north elevation and the cheek walls on both sides of the main entrance stairs. As can be seen in the photos, there appear to be structural issues related to the stone retaining wall. It is our understanding that there were some water problems which led to the reconstruction of the sidewalk along the north side of the building. The retaining wall appears to be leaning toward the building and the structural adequacy of the wall and foundation is not known at this time. The cheek walls at both the north-west and south-west corners of the main entrance stairs show evidence of deterioration with open mortar joints, cracking and rotation of the south cheek wall.

Photo 28. View Along North Elevation of Building Showing Street and Sidewalk

- Repair or reconstruct the stone retaining wall along the north elevation of the building adjacent to the sidewalk.

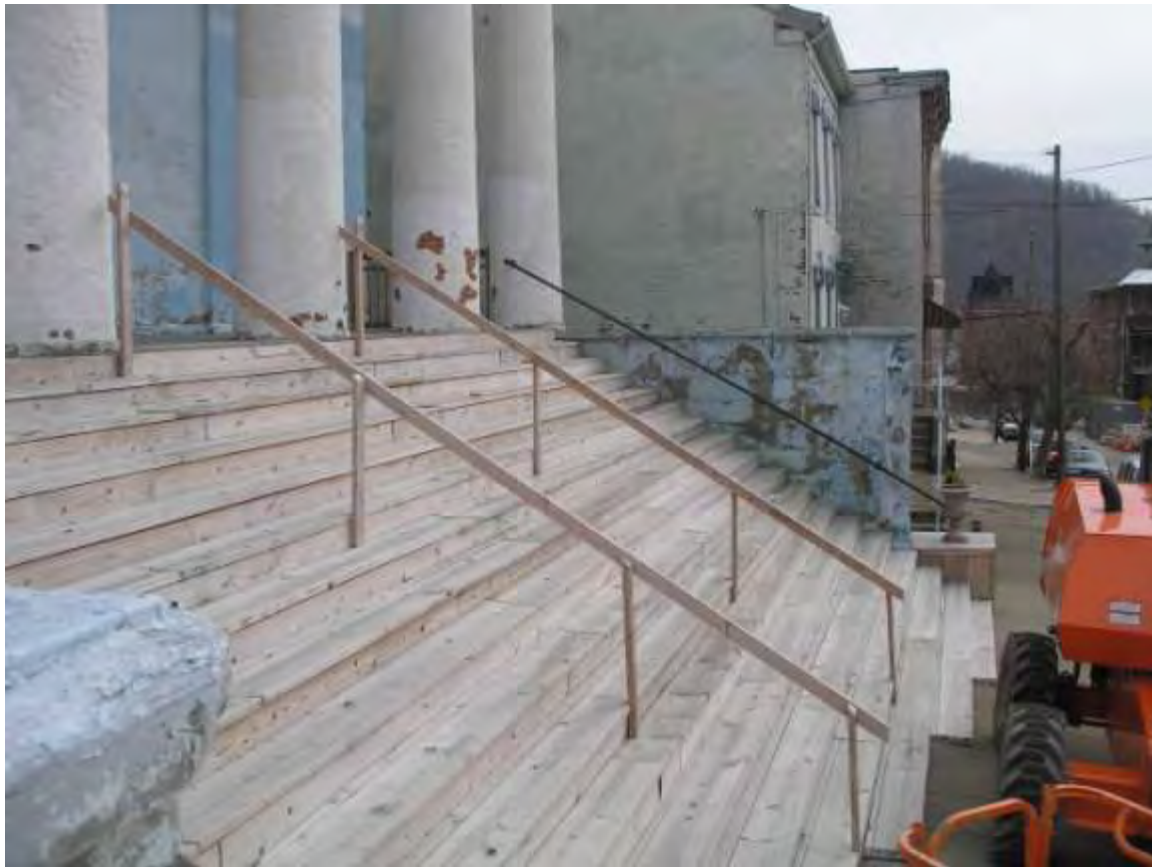
Photo 29. Steps Leading to Main Entrance on West Elevation

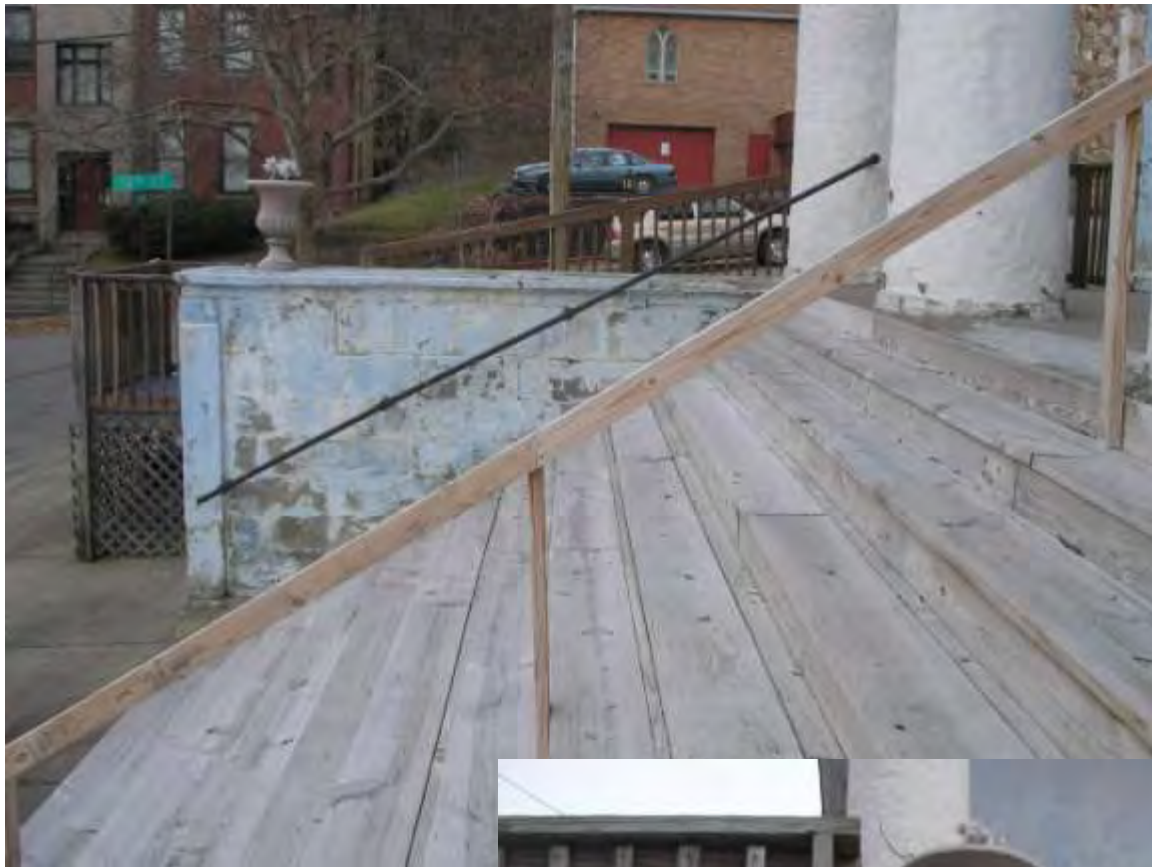
Photo 31. Inside Face of Cheek Wall at North-West Corner of Steps

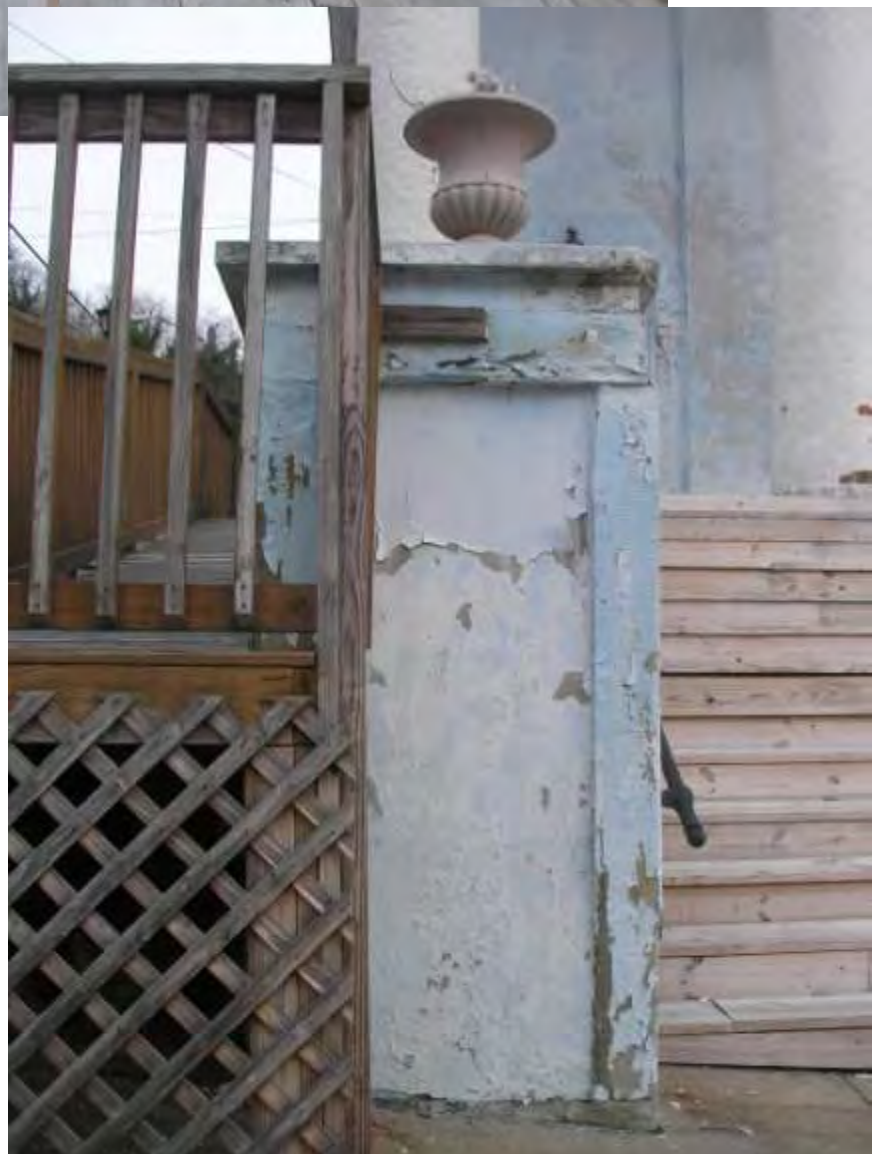
Photo 32. End of Cheek Wall at North-West Corner of Steps

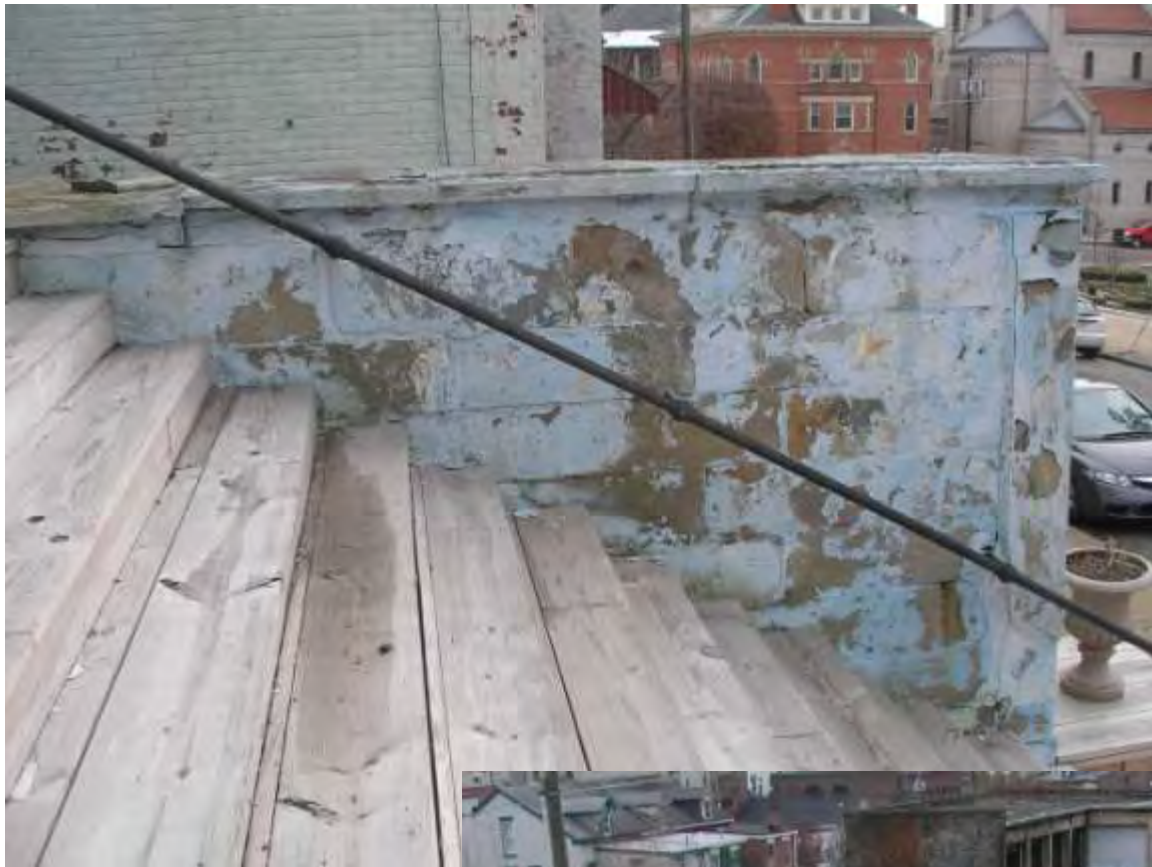
Photo 33. Inside Face of Cheek Wall at South-West Corner of Steps

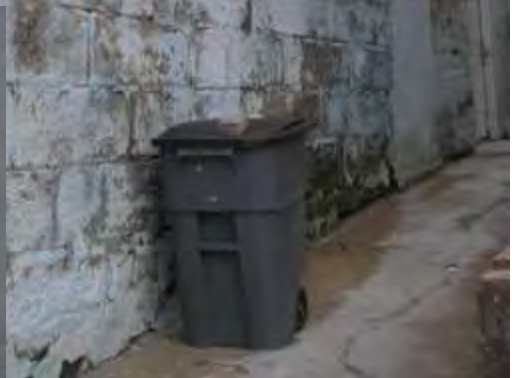
Photo 36. End View of Cheek Wall at South-West Corner of Steps Showing Wall Movement to the Outside
